## **Five-Year Review Report**

### **Second Five-Year Review Report for Ormet Corp. Superfund Site Monroe County, Ohio**

**May 2007**

Prepared by:  
**United States Environmental Protection Agency  
Region 5  
Chicago, Illinois**

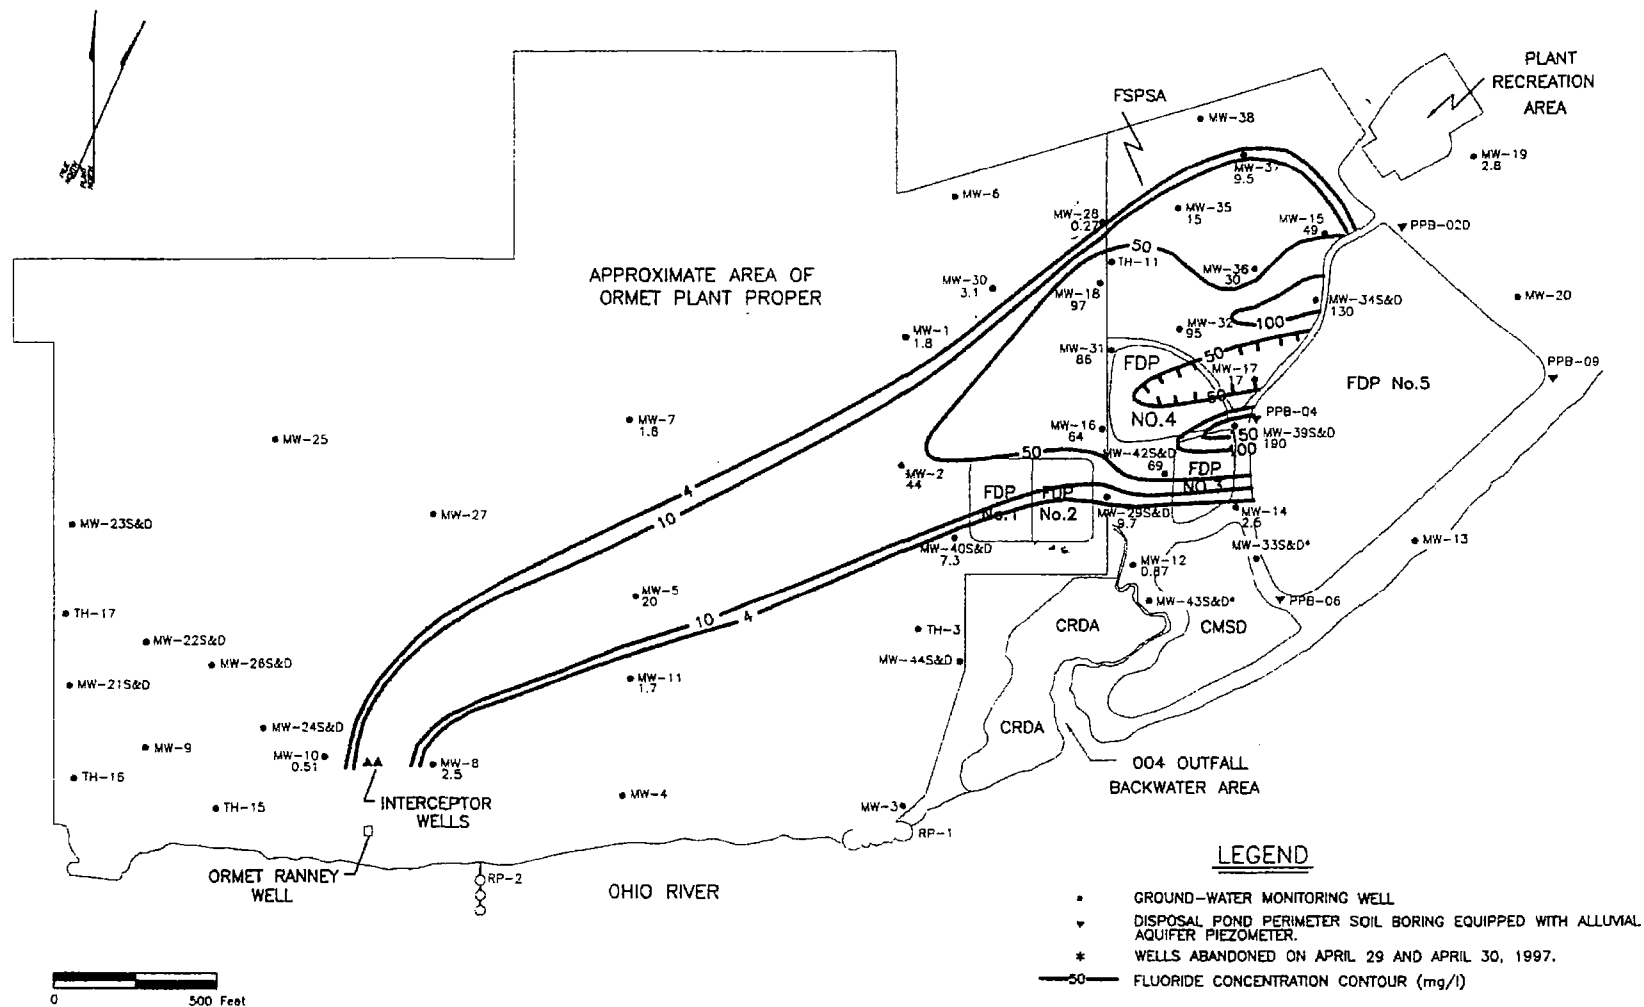
Figure 2. Fluoride Isopleth Map, Ormet Corp., Reduction Plant, Hannibal, Ohio, May 16-19, 2005  
(Obtained from map produced by HydroSystems Management, Inc.)

Cyanide amenable to chlorination, to which the MCL applies, is that portion of the total cyanide that is weakly bound in cyanide complexes or is in the form of free cyanide. It is more reactive and more toxic than the metal-cyanide complexes. The analysis for amenable cyanide is generally only performed when the total cyanide concentration exceeds the MCL, which is the clean-up level here. The cyanide occurring in the groundwater at the Ormet facility appears to be predominately the stable cyanide complexes. It is to be noted that analysis for amenable cyanide tends to be subject to a greater degree of variability than analyses for other plume indicators, such as total cyanide and fluoride. At two of the compliance wells, the most recent total or amenable cyanide concentrations were below the clean-up goal; at MW-12 the total cyanide has been below the detection limit while amenable cyanide at MW-28 has been below the MCL since May 2002 except for one measurement. In most of the wells the concentrations of amenable cyanide fluctuate so much that a trend cannot be determined. In wells MW-16, MW-31, MW-36, and MW-37 the total cyanide appears to be holding fairly steady. In May 2005 there were significant increases in the total cyanide concentrations in several wells along the western edge of FDP-5. The increases occurred in wells MW-15, -34S, -34D, -17, and -39D. There was an increase in MW-39S in May 2004, and the concentration decreased only slightly in May 2005. There was no significant increase in well MW-14 in May 2005. The concentrations in these wells will be followed closely over the next few years. It is not known at this time whether the significant increases are from the soil flushing or whether FDP-5 is contributing to the increases.
